## St. Peter's, Caversham Bell Overhaul, 2019

An inspection of the bells in 2017 revealed that although the installation was in generally good order there were signs of fair wear and tear arising from the 45 years' use since the present installation in 1973. A full overhaul was therefore undertaken to remedy this, and to take the opportunity to correct certain operational issues.

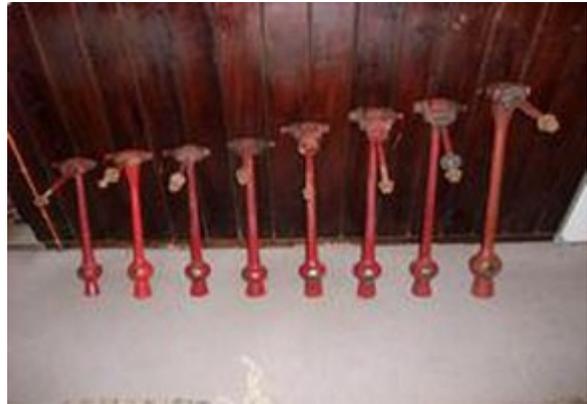
The clapper pivots were worn, and the clappers were removed and taken to Whites' workshop to be rebushed. The staple (the fixed spigot which attaches the clapper to the bell) of the no.3 clapper was found to be cracked, so a replacement staple was provided. The existing tenor clapper was an oversize replacement of ductile iron following a failure not long after the original installation, so has been replaced with a correctly sized wrought iron clapper to make the tone better in keeping with the rest of the peal.

The clappers removed; 1 to 8, left to right

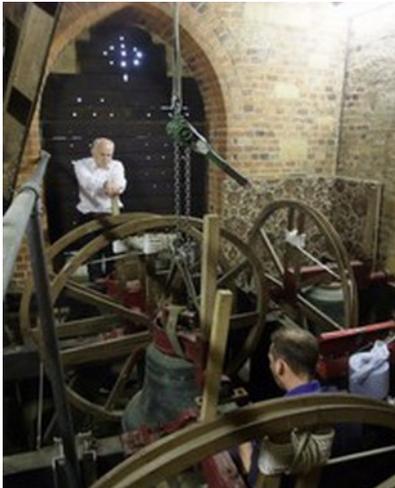
The main bearings were opened for inspection, and regreased as necessary. The tenor was lifted from its mounting on one side. The ball-race was found to have two grooves running round the inside on each side, so not in good condition, and was replaced. The 2nd and 5th were lifted from their mountings and inspected. The bearings were found to be in good order. The cap was removed from the bearings on one side of the 6th and 7th and the bells were rung up. There was no undue vibration or sound from the bearings as the bells were rung. After inspection, the conclusion was that the bearings of these bells were in good condition.

Bell no. 5 lifted to inspect bearing

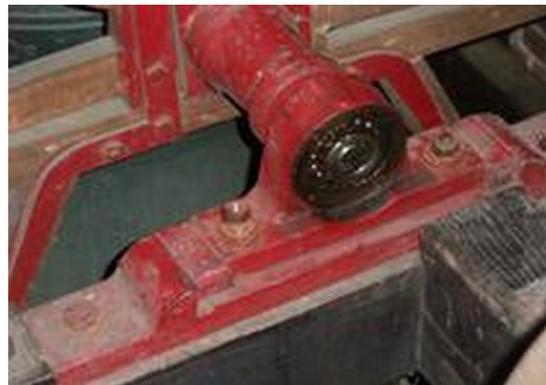
Bearing of tenor opened for inspection

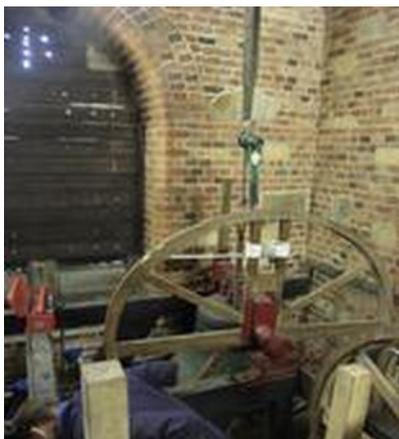
Tenor bell lifted to remove old bearing

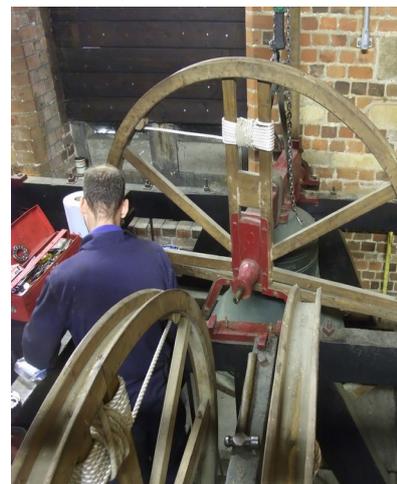
Tenor bell with old bearing removed

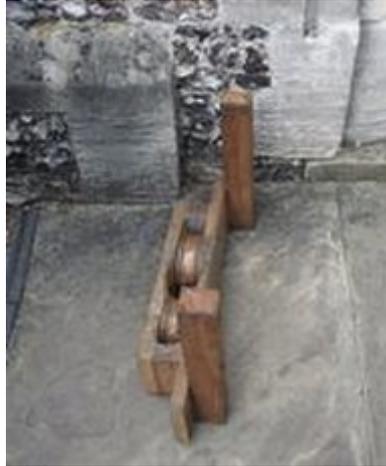
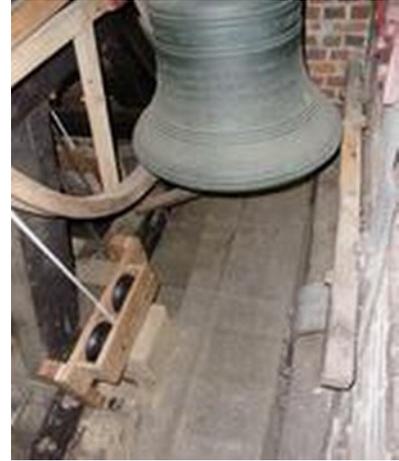
The pulleys of bells nos. 3, 5 and 6 were worn, and have been replaced with new ones. The new pulleys are of cast nylon (black) instead of wood, as shown in the picture of bell no.3

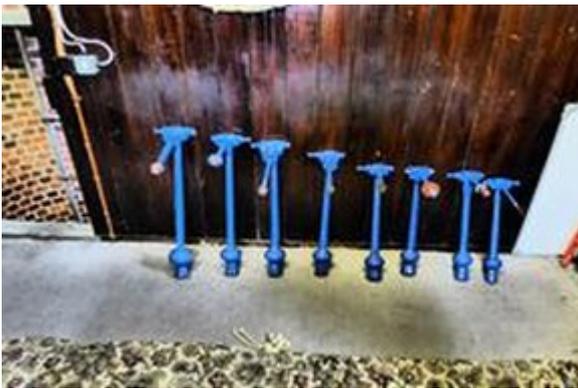
The rebushed clappers, left to right, tenor to treble. Clapper for no.3, with new staple, is 3<sup>rd</sup> from right, with washer.

The rebushed clappers were reinstalled, using tapered washers where necessary to even the striking, particularly of the oddstruck no. 3., to within a maximum acceptable difference between hand and back stroke of 20 milliseconds.

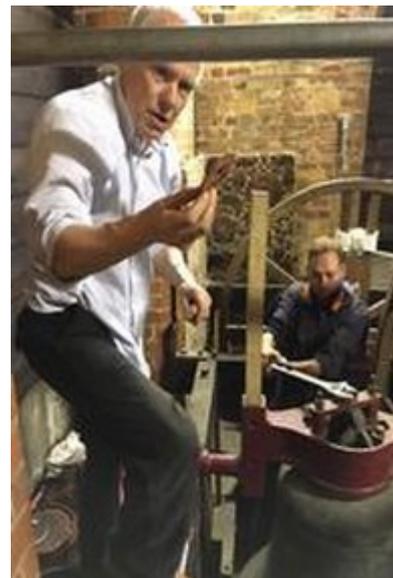
Doug with new washer; James tightening staple nut on no.6

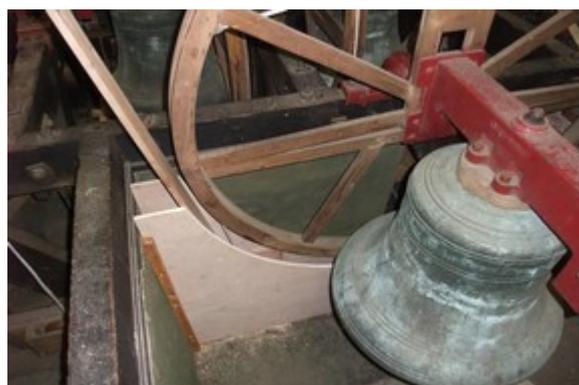
To attenuate the sound from the no.7 bell reaching the ringing chamber, an acoustic baffle has been installed.
